Miscellaneous Paper CERC-93-8  
August 1993

## Coastal Geologic and Engineering History of Presque Isle Peninsula, Pennsylvania

by *Richard J. Gorecki*  
*U.S. Army Engineer District, Buffalo*

*Joan Pope*  
*Coastal Engineering Research Center*

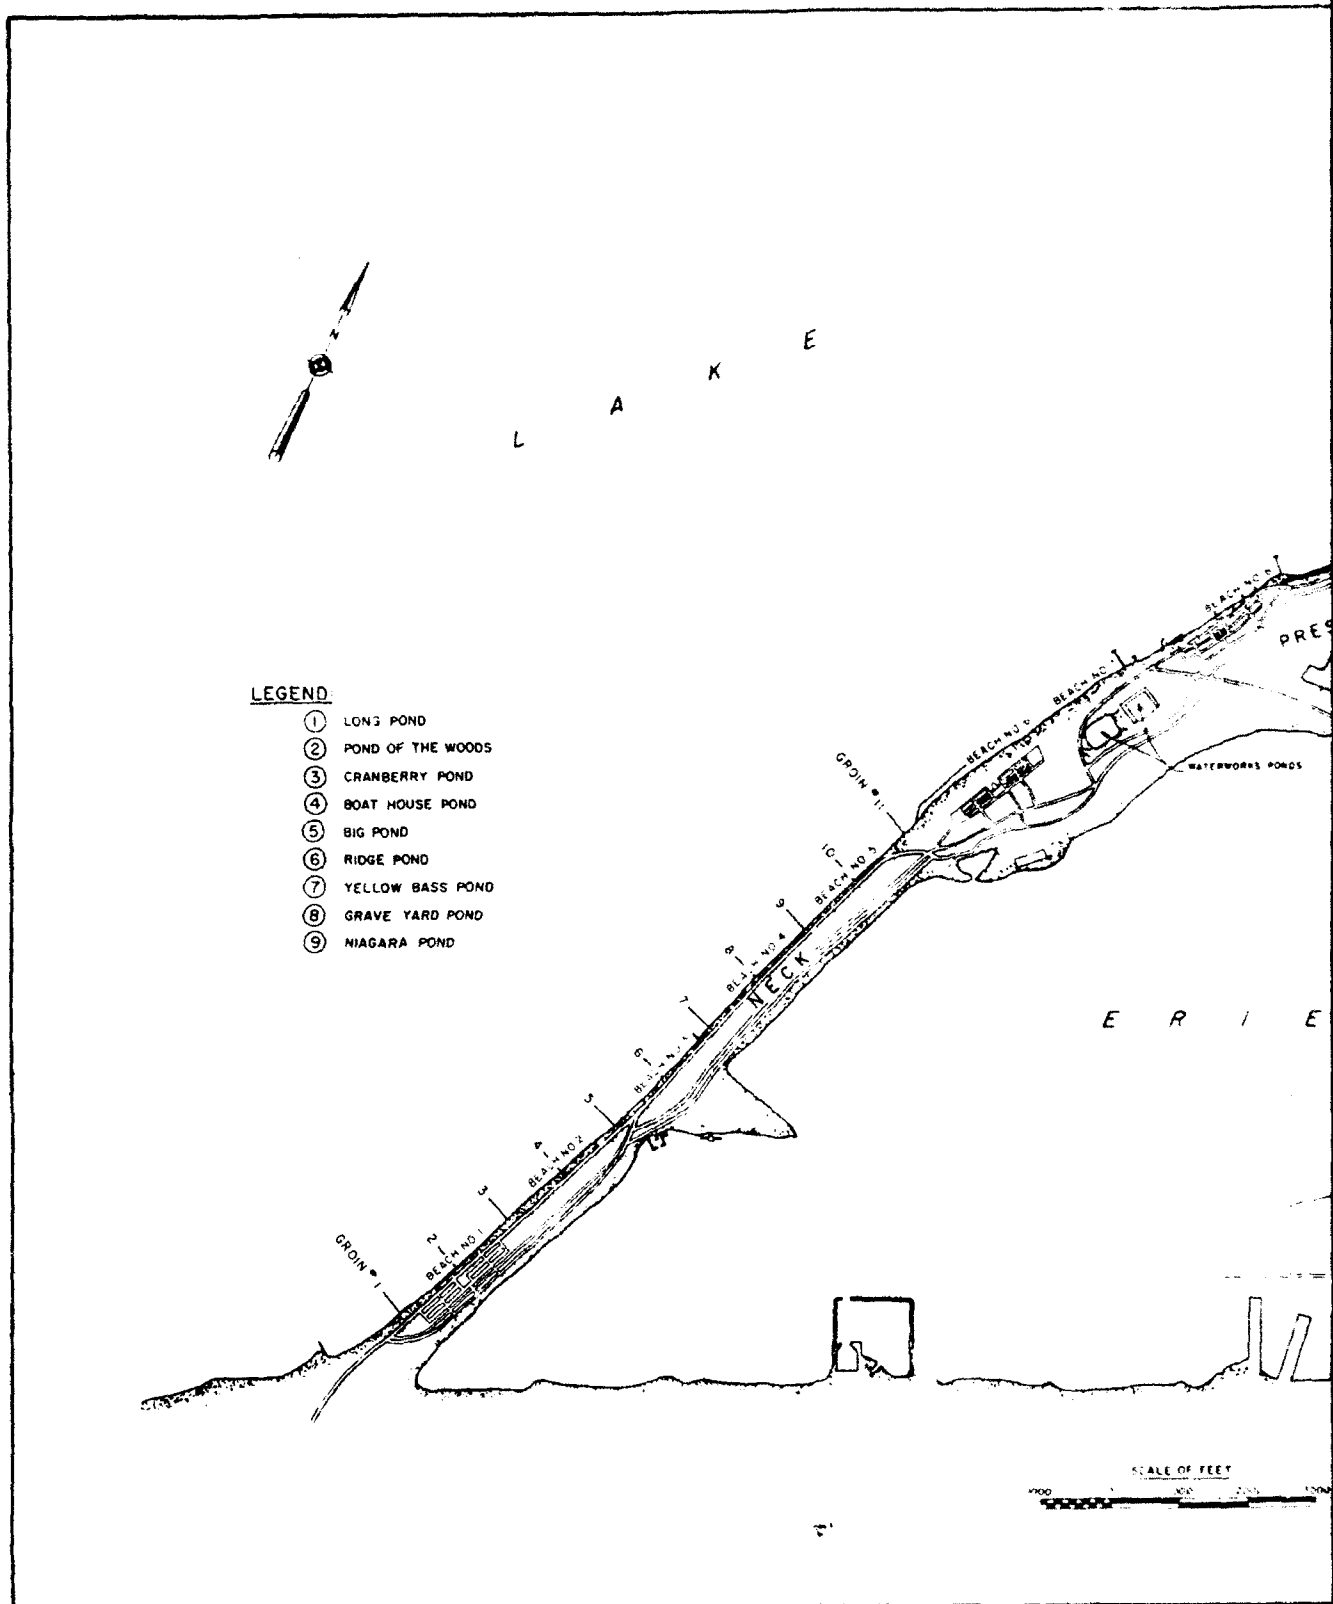
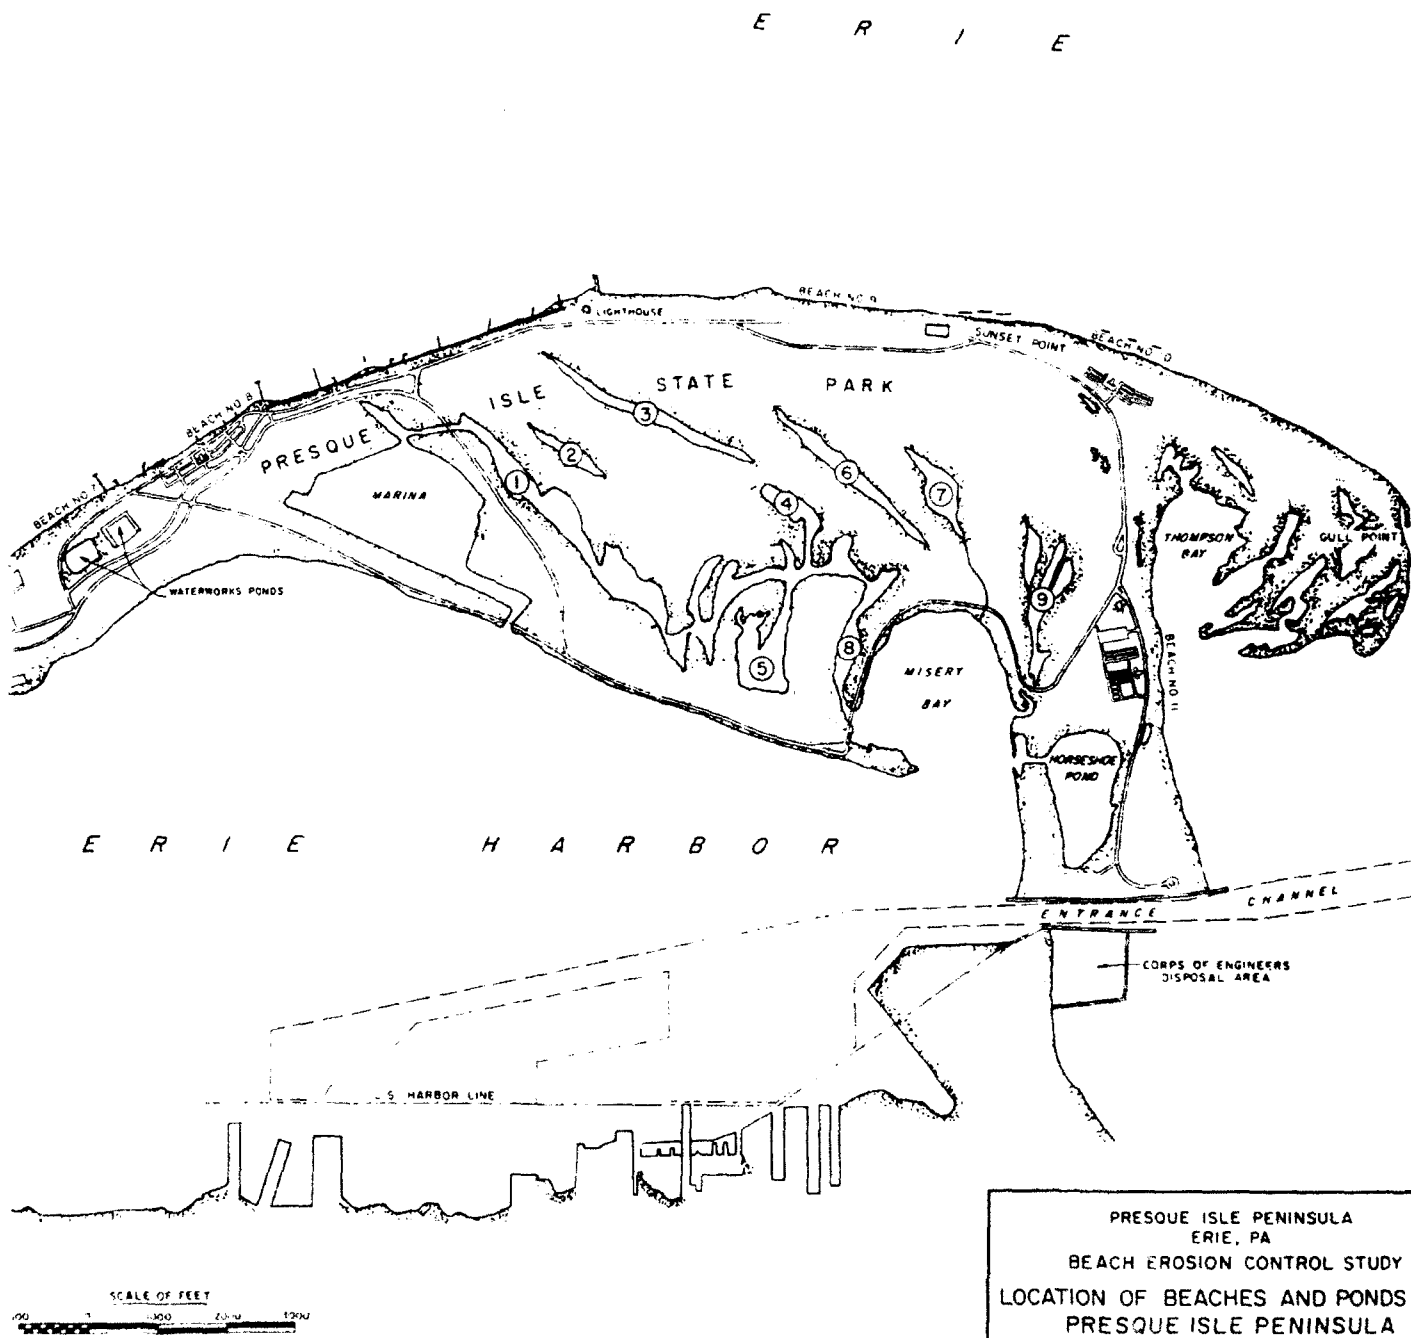
Figure 2. Location of beaches and ponds on Presque Isle Peninsula  
(USAED, Buffalo 1980)

PRESQUE ISLE PENINSULA  
ERIE, PA  
BEACH EROSION CONTROL STUDY  
LOCATION OF BEACHES AND PONDS ON  
PRESQUE ISLE PENINSULA  
U.S. ARMY ENGINEER DISTRICT BUFFALO  
TO ACCOMPANY FINAL PHASE I GENERAL DESIGN MEMORANDUM  
JUNE 1980

The lakeward perimeter of Presque Isle is about 9 miles. The lakeward shoreline has been segmented into 11 bathing beaches by the Pennsylvania State Park Services. These beaches vary in width and, with the exception of Beach No. 11, have had a history of serious erosion for at least 160 years. The bathing beaches are backed by picnic areas, and five major beach areas are provided with bathhouse and parking facilities. Roadside parking provides beach access to intervening beach and picnic areas. Over the last 16 decades, numerous protective works consisting of groins, revetments, bulkheads, and offshore breakwaters have been constructed to halt erosion.

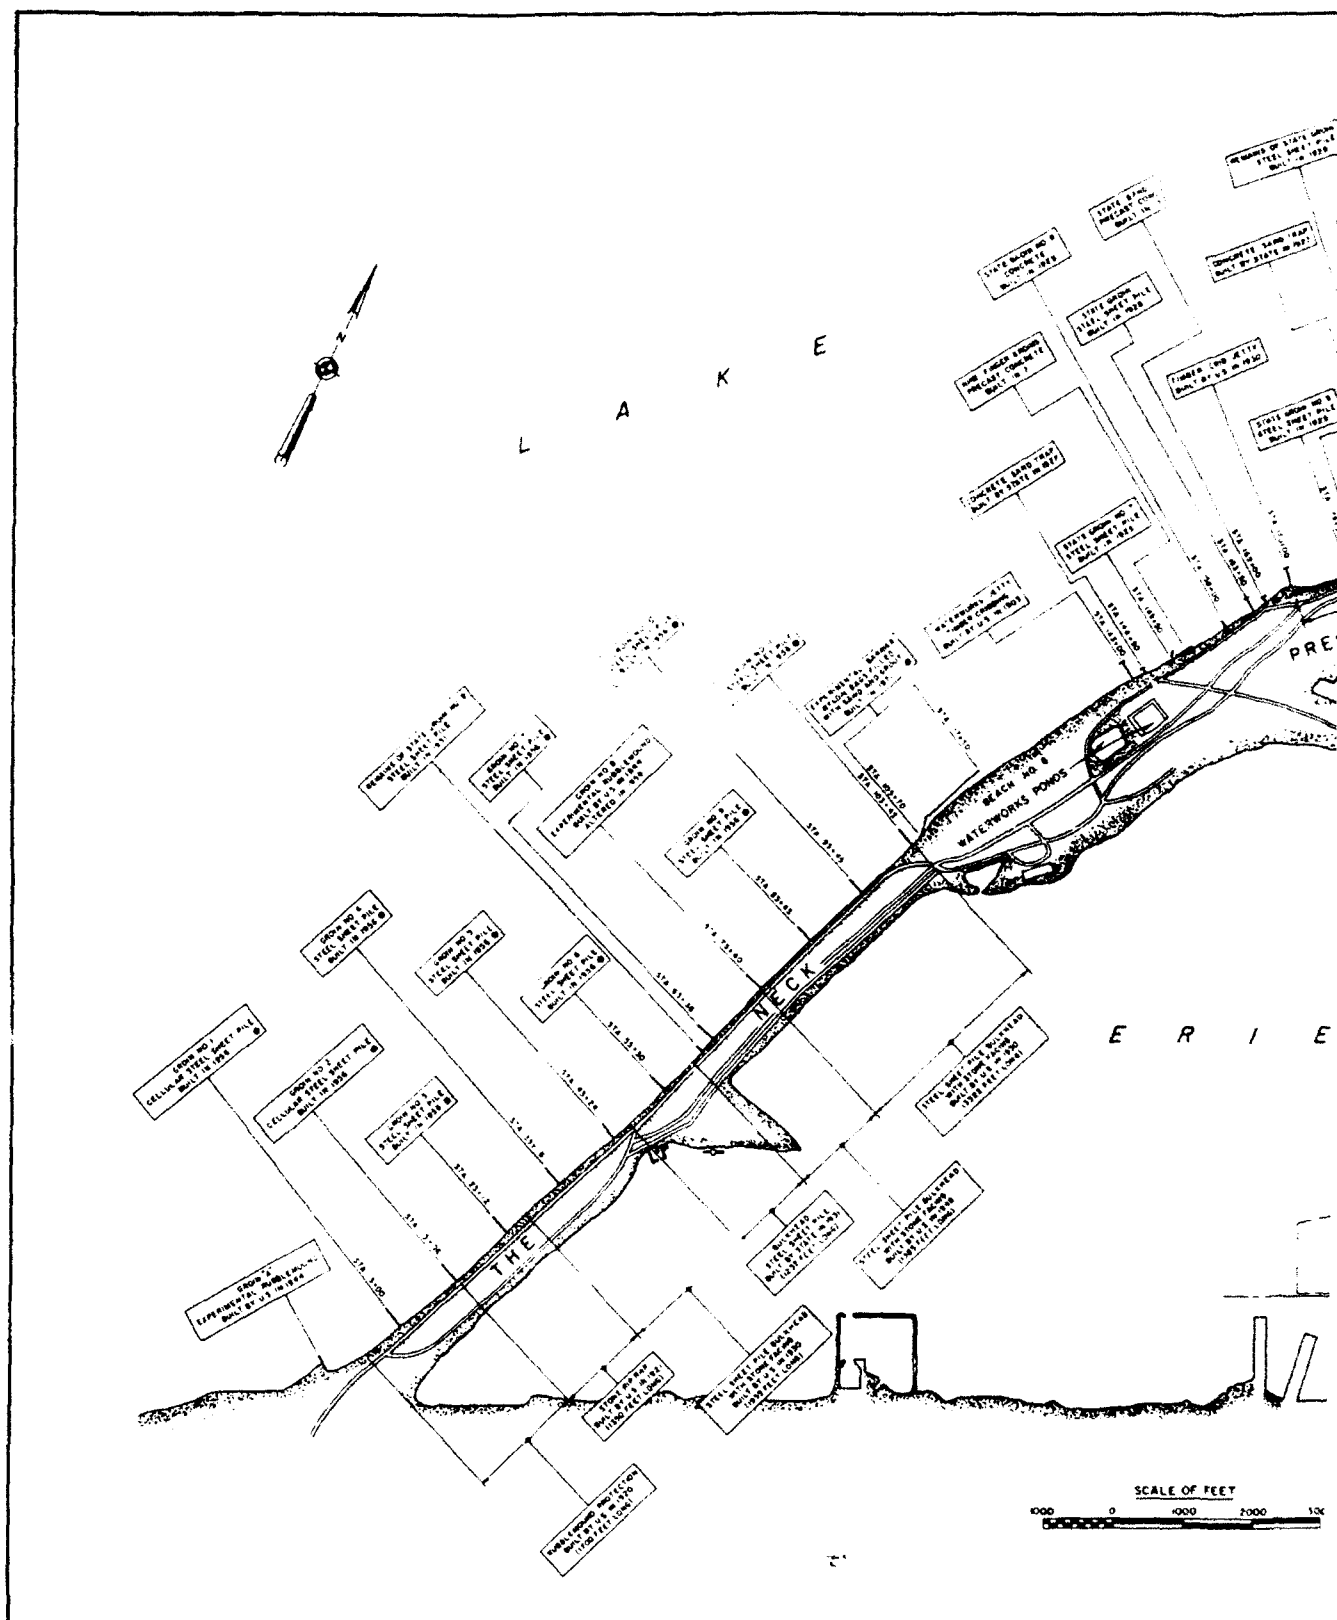
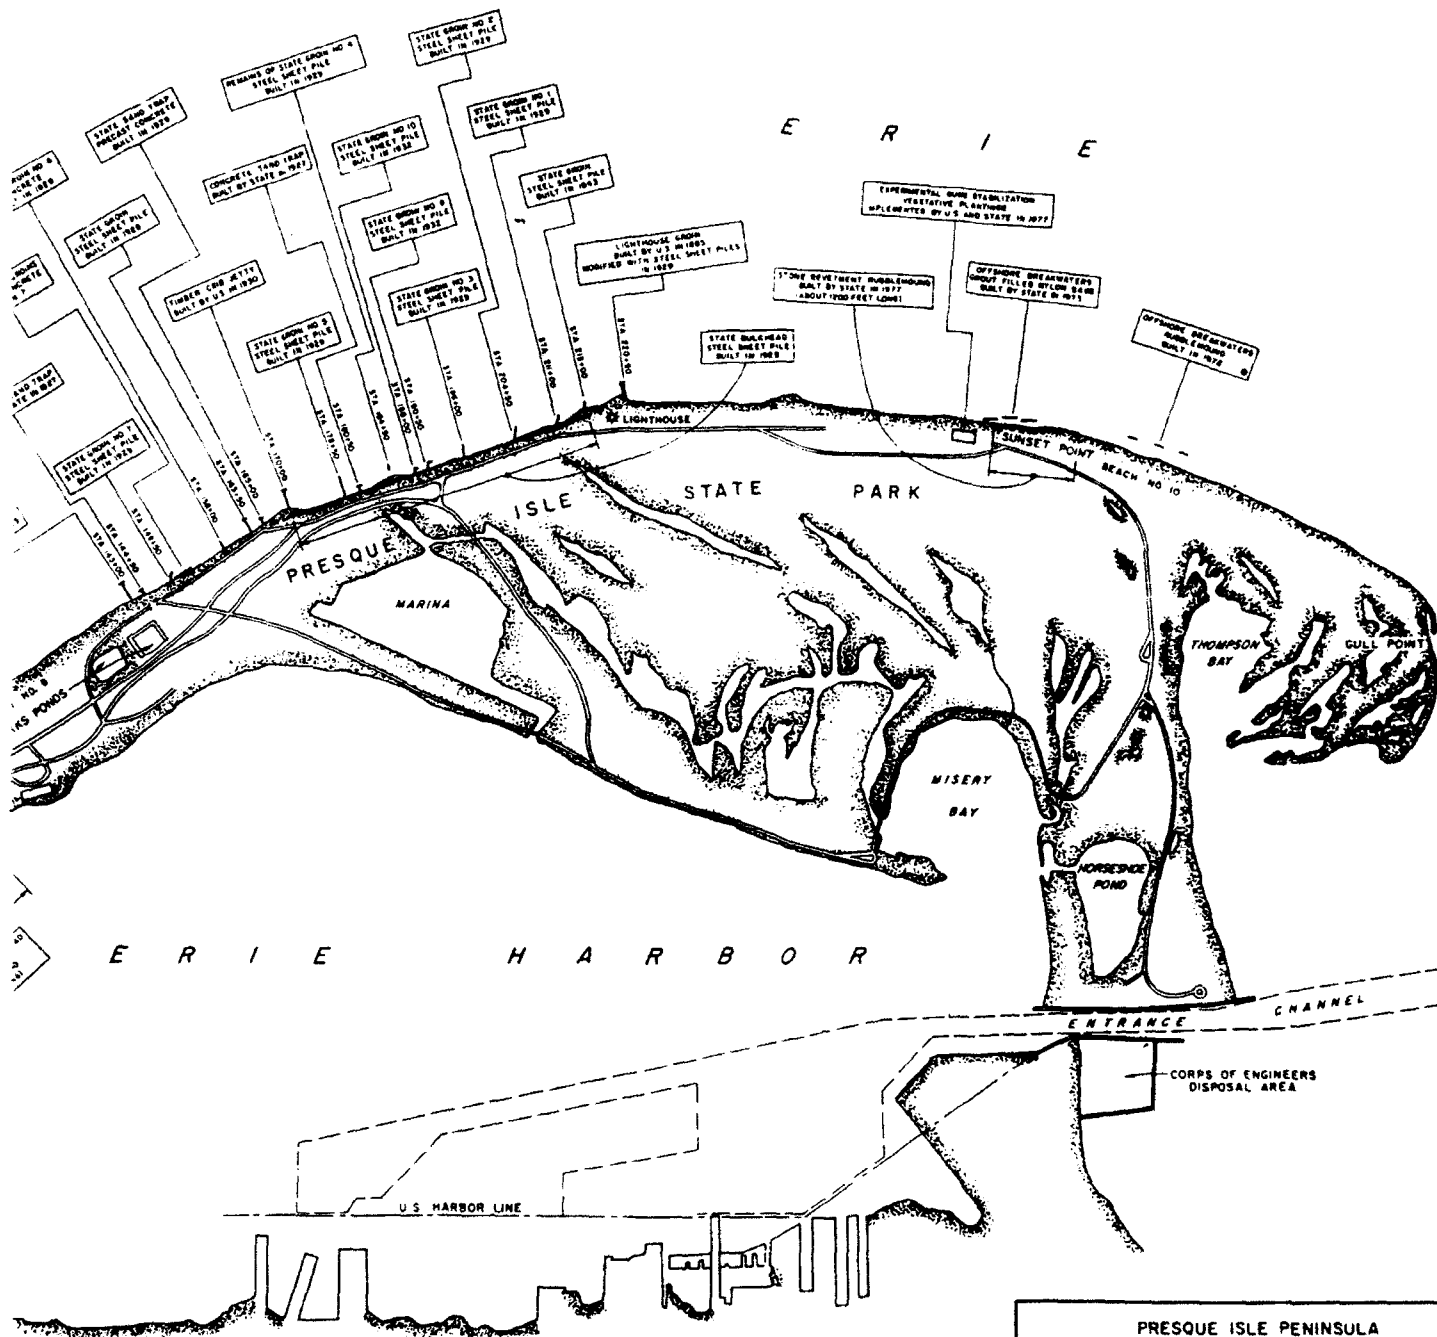
Figure 39. Shore protection structures existing at Presque Isle prior to breakwater construction (USAED, Buffalo 1980)

PRESQUE ISLE PENINSULA  
ERIE, PA.  
BEACH EROSION CONTROL STUDY  
EXISTING PROTECTION STRUCTURES  
U.S. ARMY ENGINEER DISTRICT BUFFALO  
TO ACCOMPANY FINAL PHASE I GENERAL DESIGN MEMORANDUM  
JUNE 1980

Presque Isle Peninsula provides natural protection to Erie Harbor, and it was for the purpose of preserving the harbor that shore protection works at Presque Isle were originally constructed. The structures built for preservation of Presque Isle Peninsula during the 1800's and early 1900's were mainly of timber construction. These structures had a useful life of only a few years. The 1922 River and Harbor Act reconveyed Presque Isle Peninsula to the State of Pennsylvania for park purposes and its care and protection shifted to preserving a unique natural and environmentally sensitive area which offers a wide variety of recreational and educational opportunities. During the period from 1920 through 1978, rubble-mound and steel sheet-pile construction methods were implemented. These types of construction are more durable and longer lasting. Structures built of these types of construction made up the majority of the protective structures in existence along the peninsula prior to construction of the breakwaters. The locations of these protective structures along Presque Isle Peninsula, the type of construction utilized, the date the structures were built, and who built them are presented in Figure 39.

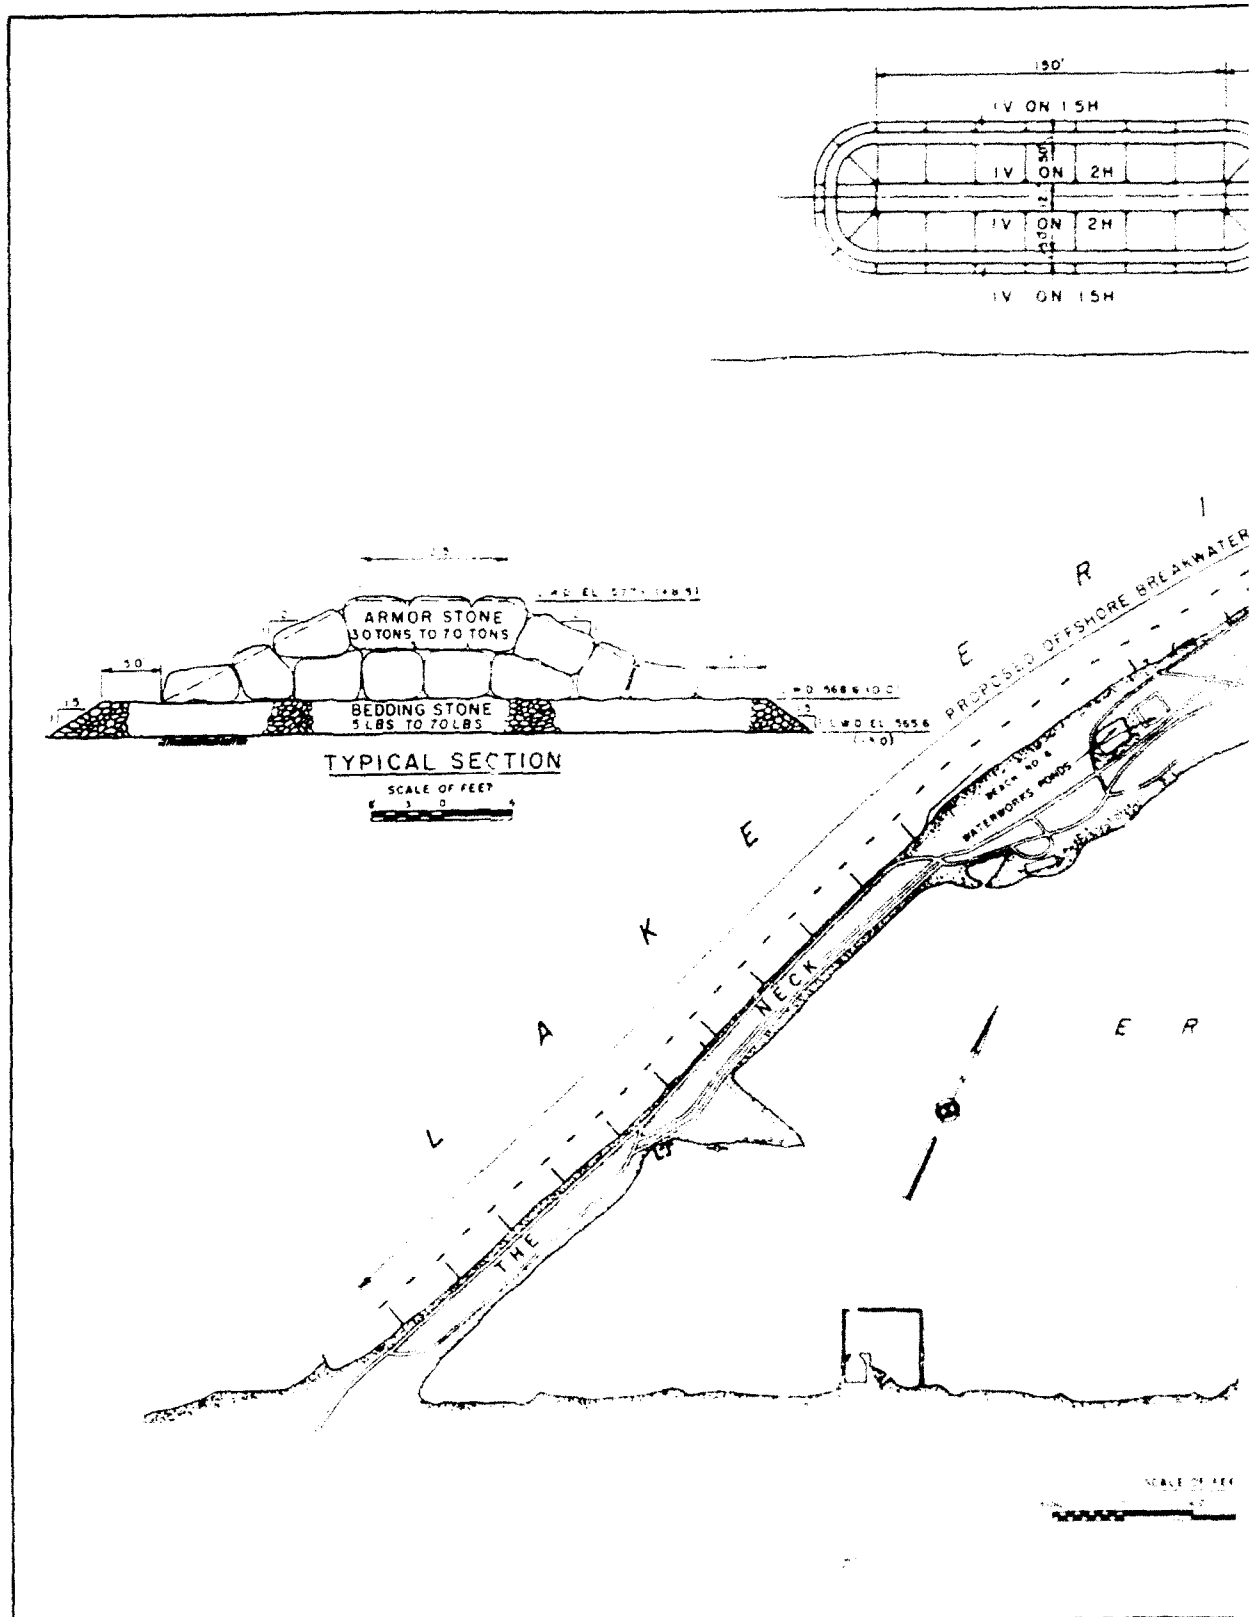
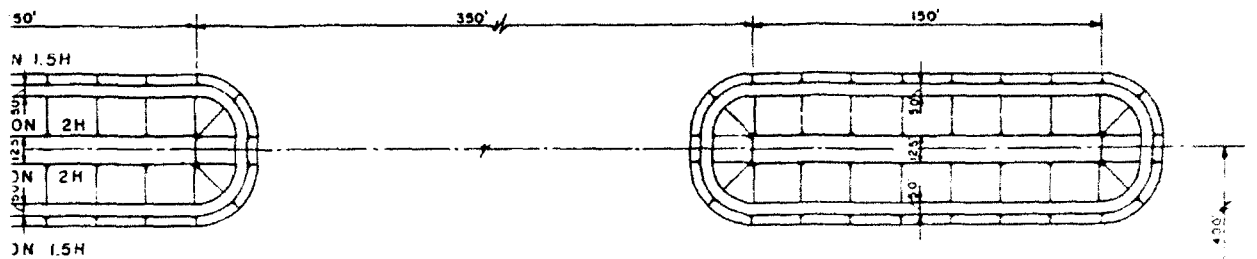
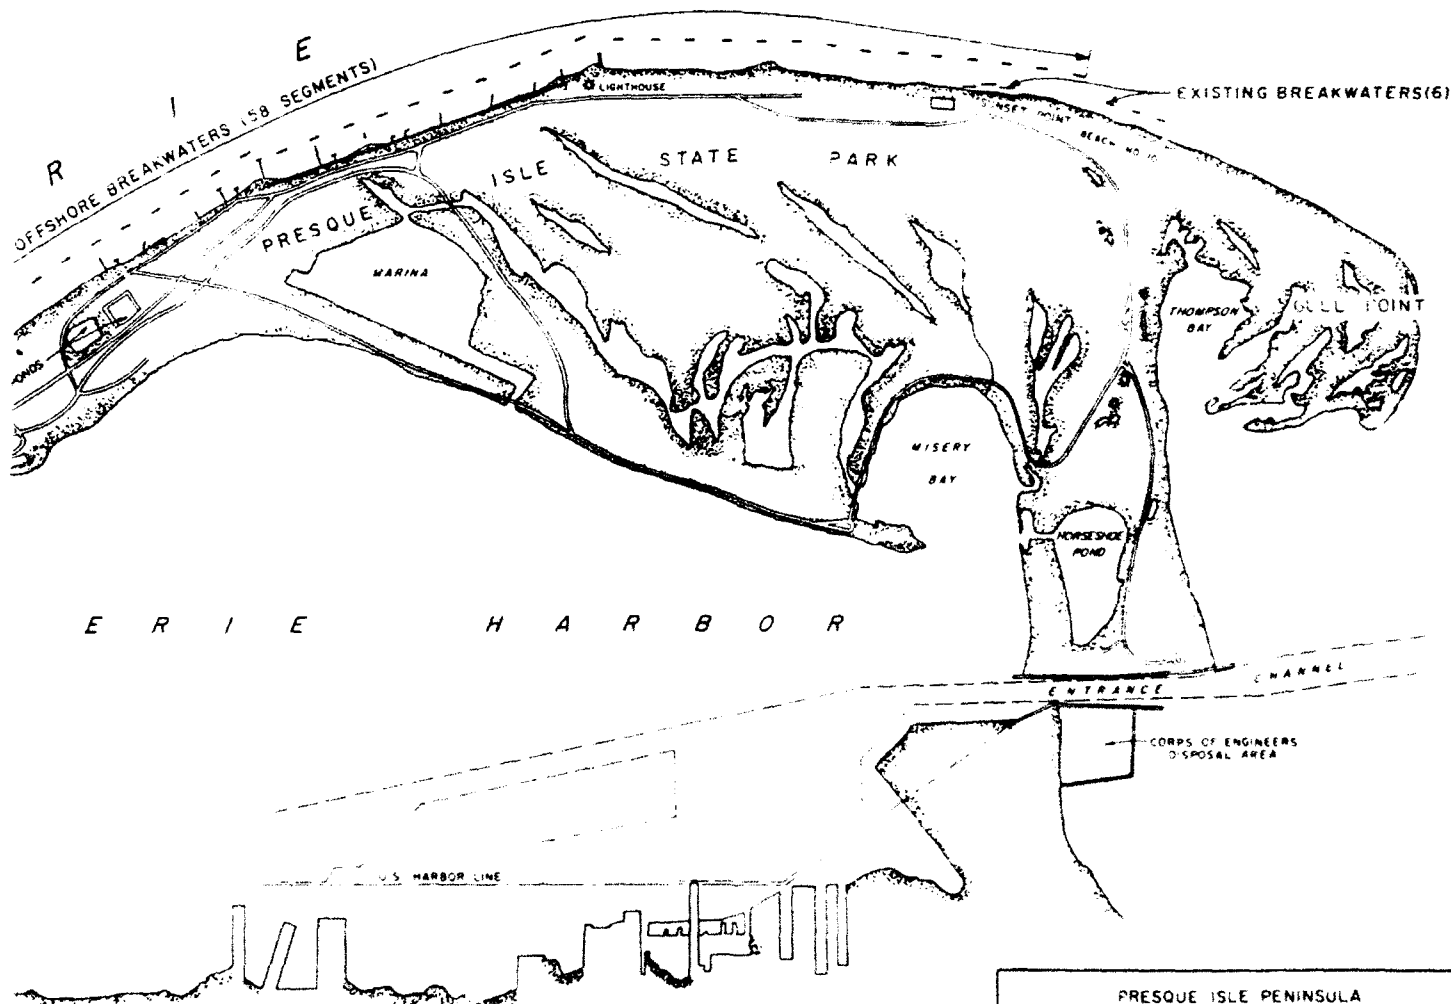
Figure 42. Present authorized plan of erosion control structures at Presque Isle (modified from USAED, Buffalo (1986))

**BREAKWATER PLAN**

PRESQUE ISLE PENINSULA  
ERIE, PA  
BEACH EROSION CONTROL STUDY  
SEGMENTED BREAKWATER  
ALTERNATIVE

The plan of improvement recommended in the Phase II GDM is shown in Figure 42 and consists of constructing structures for wave attenuation and beach restoration along 5-1/2 miles of shoreline on the lakeward side of Presque Isle Peninsula. The recommended plan was designed to protect and maintain the environmentally unique Presque Isle Peninsula and to satisfy the projected recreational beach demand from the surrounding area. The plan of improvement requires the placement of an estimated 560,000 tons of sand fill to provide a protective berm with a minimum 75-ft width and a crest elevation 10.0 ft above LWD; construction of an estimated 58 offshore rubble-mound breakwater segments aligned parallel to the shoreline; and an annual nourishment requirement of approximately 38,000 cu yd of sand fill in order to maintain the protective sand berms at the minimum design 75-ft crest width and a crest elevation 10 ft above LWD. Section 501(a) of the Water Resources
